Treatment R-20000[®] Pinta Rulli

Anti-chemical attack treatments for ceramic rollers.
Reduce roller consumption by 50%

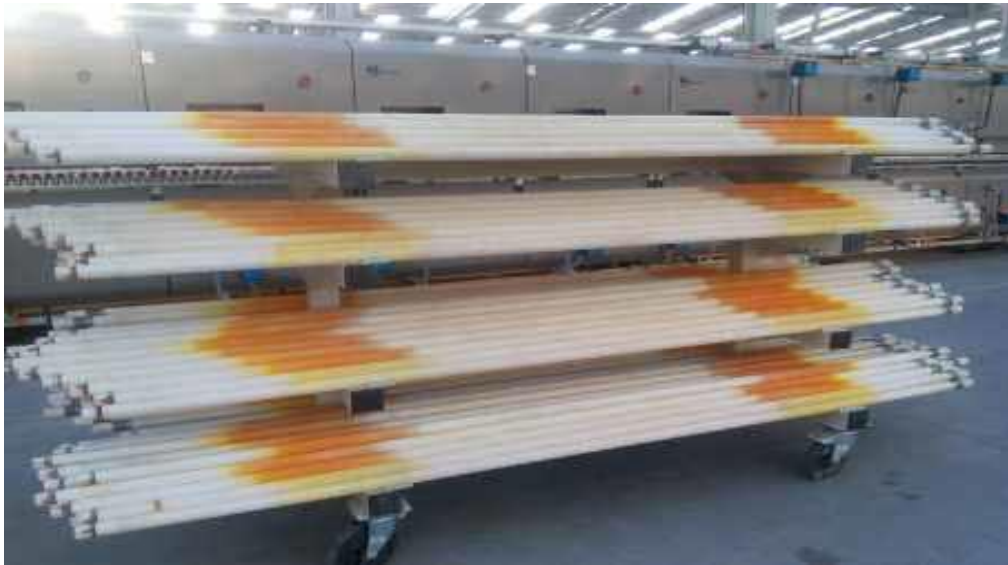
Chemically attacked rollers

With this treatment we will prevent the chemical attack from penetrating the rollers and destroying the mineralogical structure of the ceramic roller, as this is the main cause of breakage of the ceramic rollers. Sometimes we can overthink that the rollers do not resist thermal shock, but what really happens is that the roller is chemically attacked and "is sick" and therefore does not withstand temperature changes.

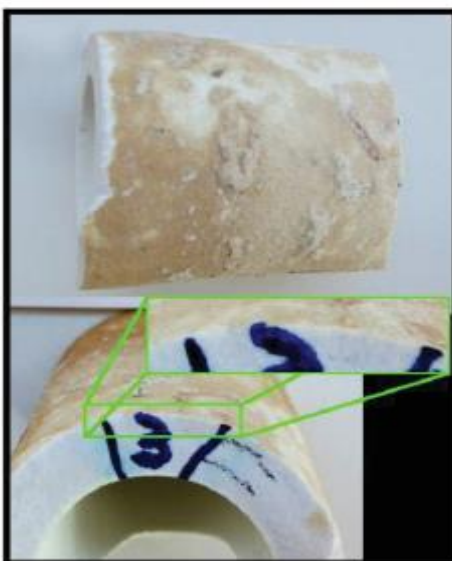
Chemical attack penetration on roller.

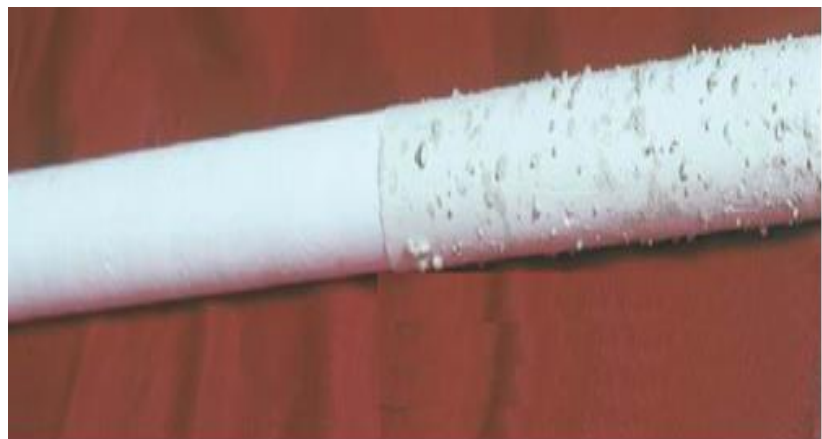
Rodillo con suciedad incrustada

The rough texture of some rollers makes it easier for dirt to adhere to the roller. After the R-20000 Pinta Rulli treatment on the rollers, the surface of the roller is extra smooth and thin, making it much more difficult for dirt to adhere.

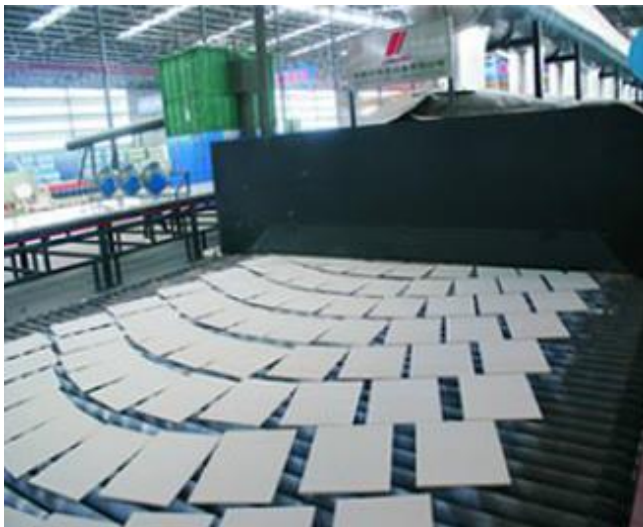
Advance uncontrolled material

Regarding bending, in order to prevent the bending roller and our material from advancing uncontrollably inside the furnace, we resort to buying rollers with a higher flexural strength, at a much higher cost than conventional ones.

We observe that when the rollers are assembled in the kiln, the first few months bend little and our material progresses normally, but in the third month we see that the races of tiles begin inside the kiln. This is due to the fact that the attack has contaminated and the roller begins to lose its properties, increasing bending day after day. This type of problem is accentuated in the new generation kilns, with widths of 3500 -3750 mm. and equipped with rollers with a diameter of 60 x 4700 mm.

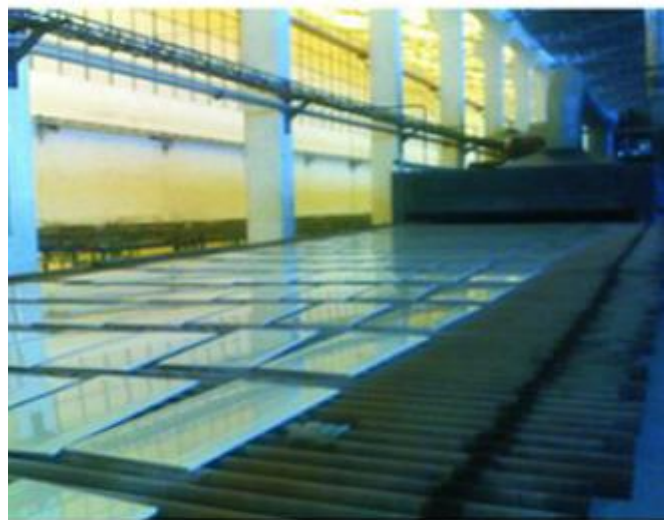
Advance material the right way

This is where our **R-20000 Pinta Rulli revestement** plays an important role, preventing the roller from becoming contaminated and bending.
